# A358 Taunton to Southfields Dualling Otter Surveys Technical Report

PCF Stage 2

HE551505-MMSJV-EBD-000-RP-LB-0038

Date: March 2021

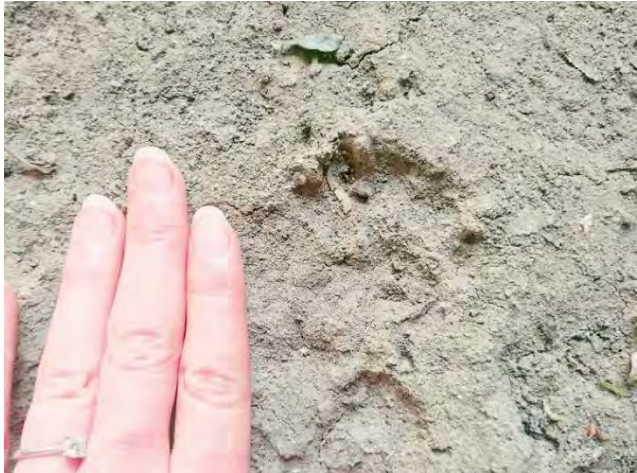
A close-up photograph showing a person's hand with fingers spread next to a soil sample. The soil is light brown and appears to be a mix of sand and silt.	21
	21/06/2017

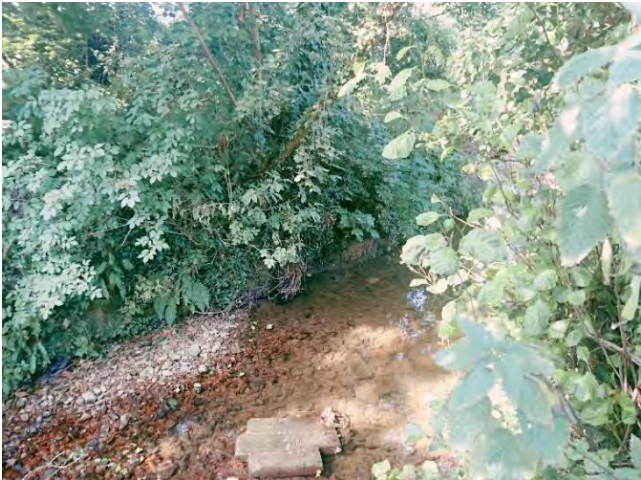
A photograph of a watercourse flowing through a wooded area. The water is clear and flows over a bed of rocks and fallen leaves. The surrounding vegetation is dense and green.	22
