A358 Taunton to Southfields Dualling Water vole Technical Report

PCF STAGE 2

HE551508-MMSJV-EBD-000-RP-LB-0046

Date: May 2021

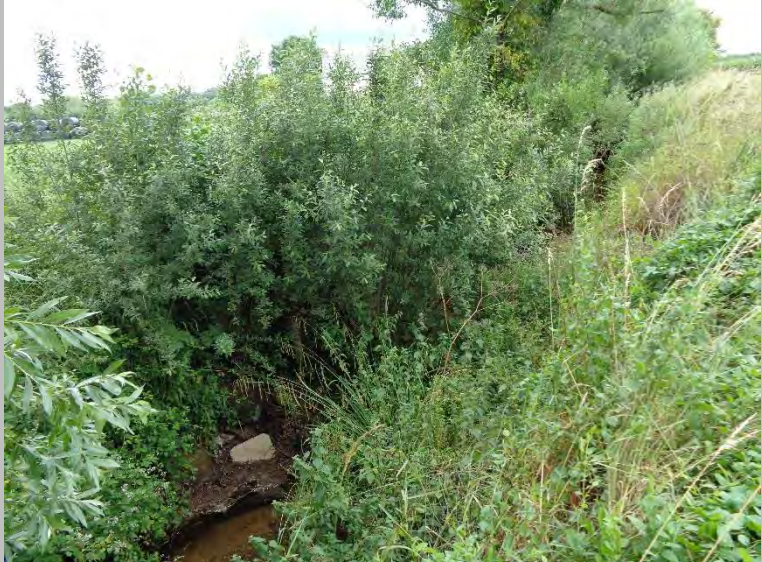
Water course	Date	Scoped out/survey required	Reason	Habitat Description	Photo
1	Not visited	Scoped out	Outside 250m buffer		
2	Not visited	Scoped out	Outside 250m buffer		
3	Not visited	Scoped out	Outside 250m buffer		
4	Not visited	Scoped out	Outside 250m buffer		
5	Not visited	Scoped out	Outside 250m buffer		
6	Not visited	Scoped out	Outside 250m buffer		
7	18.07.2017	Scoped out	Outside 250m buffer Dry	Dry ditch, overgrown with vegetation, banks trampled by livestock	
8	Not visited	Scoped out	Outside 250m buffer		
9	No watercourse assigned to this number				
10	19/06/17	Scoped out	Dry Outside 250m buffer		
11	11/06/17	Scoped out	Dry Outside 250m buffer		
12	22/06/17	Scoped out	Dry, isolated, overgrown Outside 250m buffer		
13	19/06/17	Scoped out	Dry where surveyed, ditch isolated Outside 250m buffer		
14	26/06/17 06/07/17	Scoped out	Dry Outside 250m buffer		
14a	29/06/17	Scoped out	Outside 250m buffer	<p>Suitable habitat – dense herbaceous vegetation, vertical banks with silt bars, connected to suitable habitat.</p> <p>Some natural erosion to vertical earth banks (meandering watercourse), water up to 2m in depth, 2-5m wide, moderate flow. Willow dominates overhanging treeline (60% shading) also comprises blackthorn, hazel, hawthorn, (pendulous sedge, meadow sweet, tall grasses) and bramble scrub in open section, adjacent arable crop. Slight disturbance – Public Rights of Way (PRoW) along east bank (~3m from top of embankment). Medium connectivity. Occasional silt bars. Less suitable areas comprise mossy banks within wooded areas and channel substrate comprises rocks and pebbles.</p>

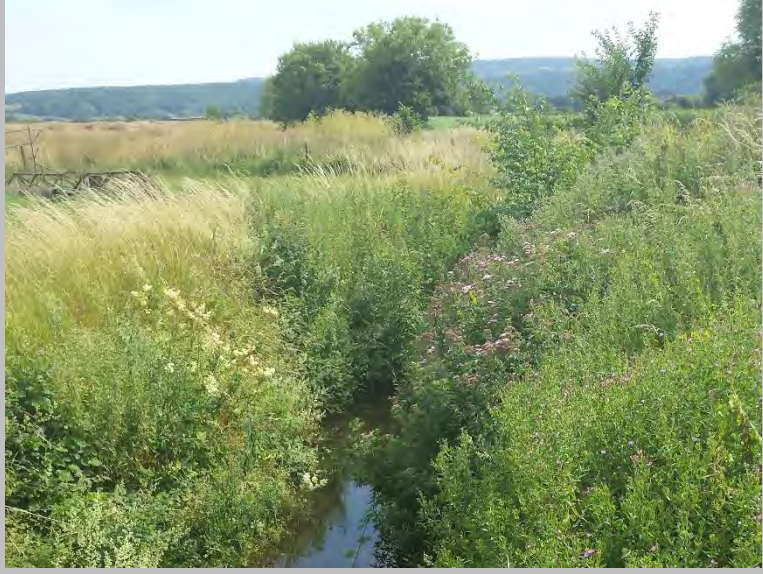
Water course	Date	Scoped out/survey required	Reason	Habitat Description	Photo
	06/07/17	Scoped out	Outside 250m buffer	<p>Suitable habitat - Short section of riparian vegetation, predominantly steep / vertical banks, some short sections of overhanging tall grasses, connected to suitable habitat.</p> <p>Vertical earth banks, 3.5m deep, 2-5m wide, slow flow. Predominantly tall grasses and herbaceous species along embankments, with trees along mid-section of watercourse length. Vegetation comprises tall grasses, pendulous sedge, blackthorn, hazel, willow, meadow sweet, alder, bramble and hawthorn. Shading 35%. Slight disturbance – PRoW adjacent. Medium connectivity.</p>

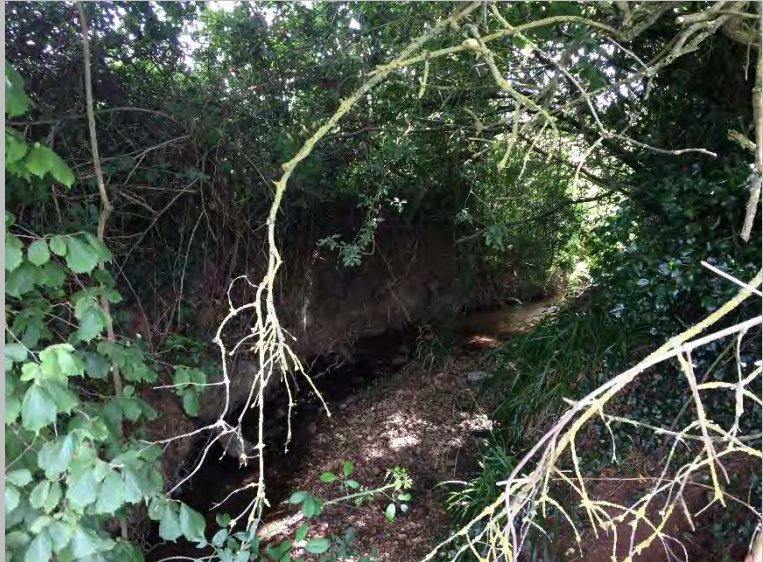
20/07/17	Scoped out southern section	<p>Unsuitable habitat - limited food source and shelter</p> <p>Outside 250m buffer</p>	<p>Predominantly shaded (80%) by bankside trees and heavily overgrown banks (bramble and hazel), with limited understorey predominantly bare or ivy covered. Some short sections of grassy, herbaceous habitat on top of banks, not bank slopes.</p>

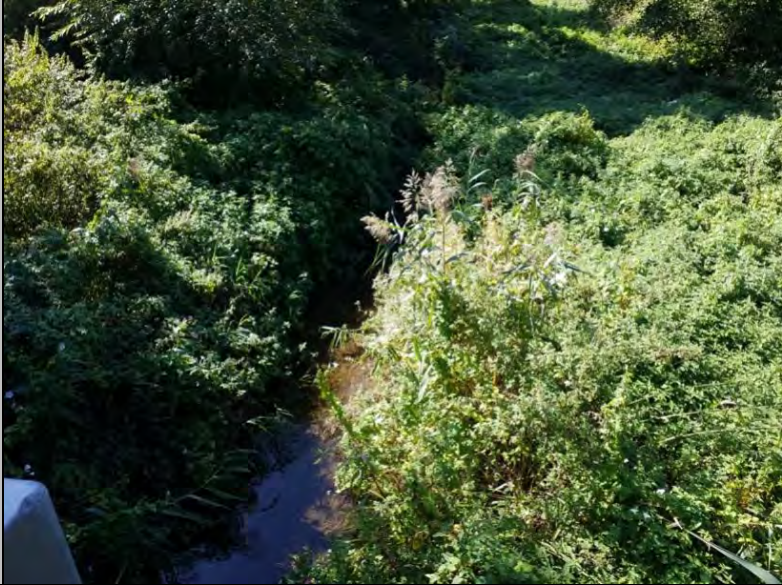
Water course	Date	Scoped out/survey required	Reason	Habitat Description	Photo
15a	20/05/19	Scoped out	Outside 250m buffer	<p>A slow flowing and shallow tributary to the River Tone. The stream has a gravel bed, dense tall ruderals on banks and vertical undercut earth banks. The stream has multiple barriers including weirs and culverts for fish and water vole migration. The water was clear showing no evidence of pollution or high turbidity. There is lots of vegetation present surrounding stream with good food availability but not many submerged weeds.</p> <p>The terrestrial habitat surrounding the stream south of the A358 bridge is currently bare earth with geotextile silt fencing preventing silt run-off from the construction site. Eventually watercourse 15a becomes a drainage ditch for the M5 motorway verge.</p>

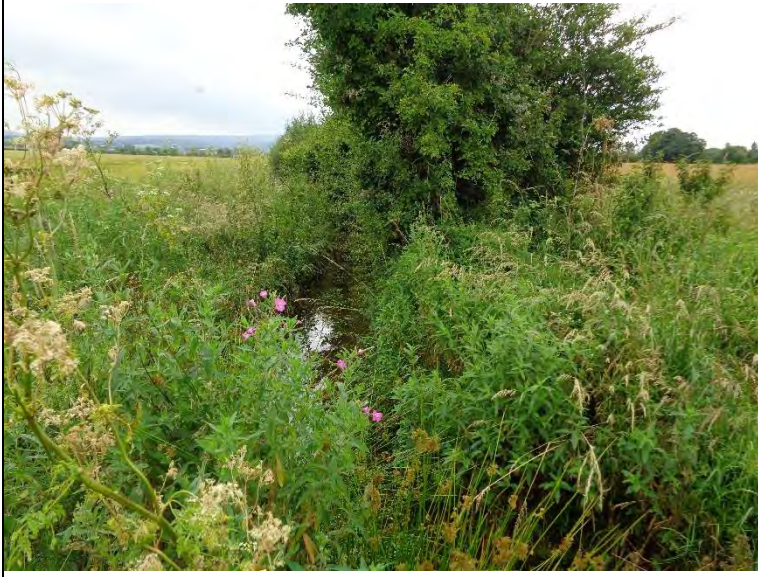
16	27/06/17	Scoped out	Dry and unsuitable habitat Outside 250m buffer		
17	27/06/17	Surveys required	Suitable habitat for water voles present	<p>Linear unmanaged grassland, hedgerows and scattered broad-leaved trees (comprise crack willow, hawthorn, blackthorn, elder and field maple) adjacent watercourse. 40% shading. Herbaceous vegetation comprises of false-oat grass, false brome, fool's watercress, greater willowherb, wood avens, water figwort. Shallow (0.5m), slow flow, 2-5m wide with vertical earth banks. Adjacent golf driving range and arable fields. Medium connectivity.</p>

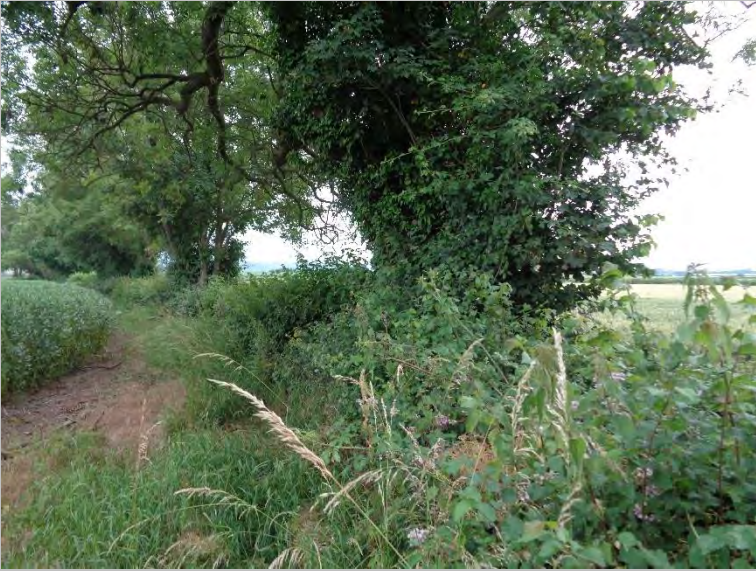
Water course	Date	Scoped out/survey required	Reason	Habitat Description	Photo
18	27/06/17	Scoped out	<p>Outside 250m buffer</p> <p>Suboptimal habitat – heavily shaded and shallow water, but good herbaceous vegetation, steep earth banks, medium connectivity, potential for commuting and foraging</p>	<p>Heavily overgrown with nettles, 50% shading comprising scattered trees (hazel, field maple and elder), tall grasses, nettles, patches of bramble scrub, ivy, blackthorn, cleavers, hart's tongue, wood avens. Water < 5m depth, 1-2m wide, low flow, arable fields adjacent.</p>

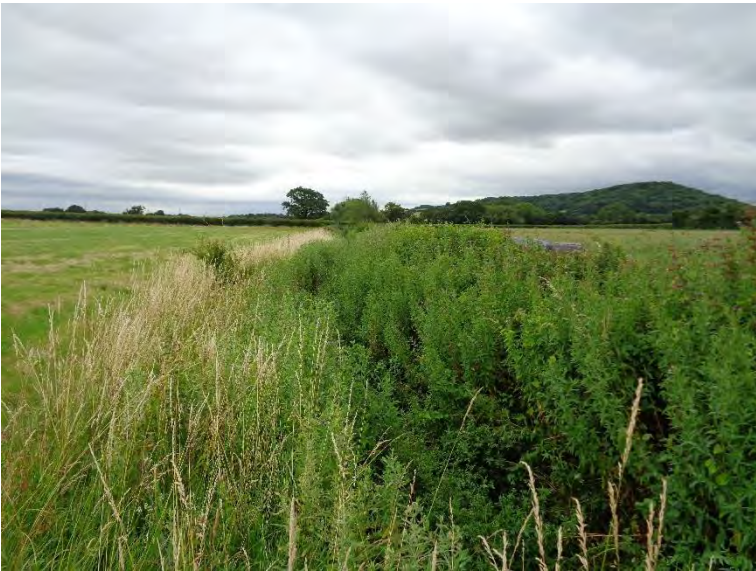
19	03/07/17	Surveys required (northern section)	<p>Sections of suitable habitat along mid-section of the extent north of Stock Road, Henlade.</p>	<p>Suboptimal and unsuitable habitat in most southerly section (still north of Stock Road, Henlade).</p> <p>Suitable habitat comprised herbaceous banks (meadowsweet, hart's tongue, hemp agrimony) and adjacent grassland dominated by false oat-grass. Bulrush and fool's watercress present within the water course. Occasional trees comprised of alder, ash, dogwood, crack willow, English elm, elder, field maple, goat willow, blackthorn and hawthorn. Food sources present include sedges, greater willowherb. 60% shading. Overall, slow flow, shallow (<0.5m), narrow drainage ditch (1m) with vertical earth banks.</p>

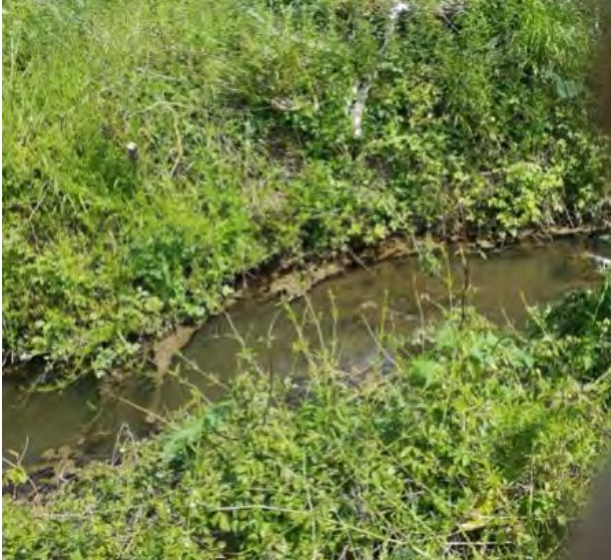
22/05/19	Surveys required (southern section)	<p>Sections of suitable habitat present</p>	<p>Good surrounding habitat with plenty of vegetation for shelter and food availability. The eastern end is heavily shaded with predominantly bankside trees and little submerged vegetation. The western section is more open with more submerged vegetation and foraging opportunities. Lots of recent tree felling on the western end with high recent disturbance. this is also creating barriers to distribution to the west with construction and with felled trees in watercourse. Possibility of pollution entering watercourse from ongoing construction.</p>

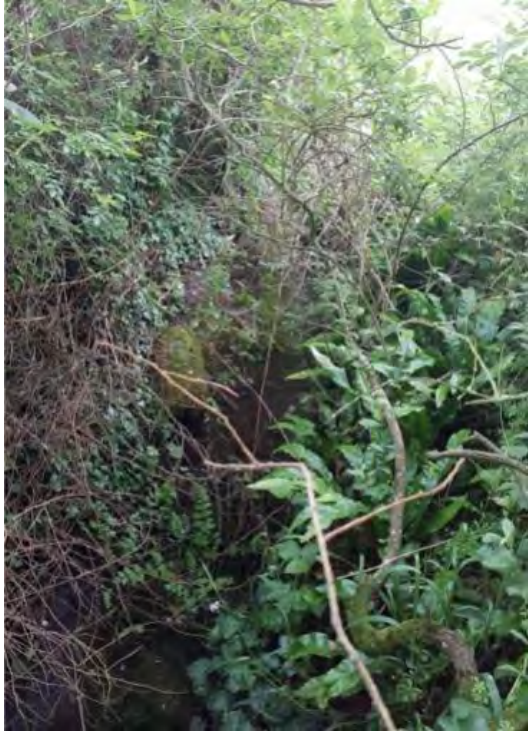
Water course	Date	Scoped out/survey required	Reason	Habitat Description	Photo
20	23/05/18	Surveys required	Sections of suitable habitat present	Very shallow ditch overgrown with bramble with little access to most of the stream due to the dense vegetation to fully assess. Mostly bramble and ferns present. Due to this the watercourse is almost completely shaded and there is minimal disturbance. Land adjacent is pastoral/arable farmland. The bank is mostly steep with shallow sections in places. Water depth ranges from 0.5-1m.

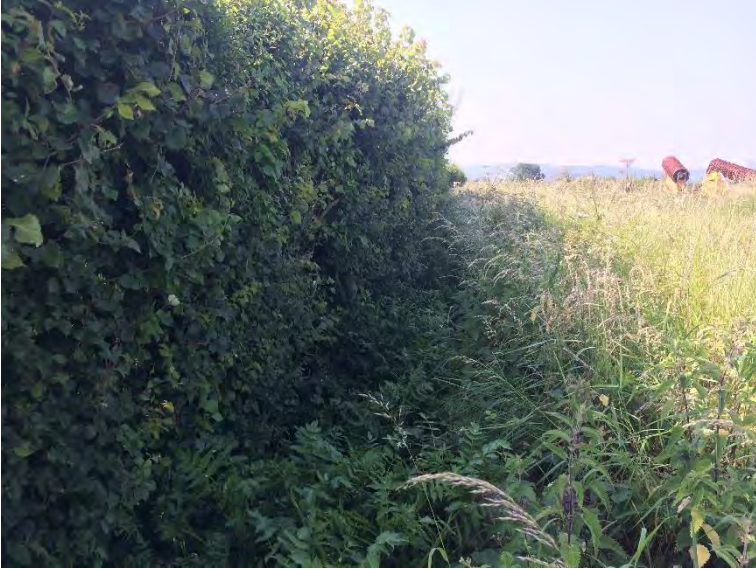
21	20/06/17	Surveys required	Suboptimal habitat (water level very low and covered in duck weed in places), however, good connectivity to adjoining watercourse 20 (which joins WC19) and 17a (which joins WC17 where water voles have been recorded).	Hawthorn, field maple and hazel hedgerow, hogweed, cleavers, ivy, bramble, sorrel, clover, pendulous sedge, thistles, horsetail and perennial rye grass result in 70% shading. Hemlock water dropwort dominates standing water (>2m depth), southern and north ends dominated by duckweed.

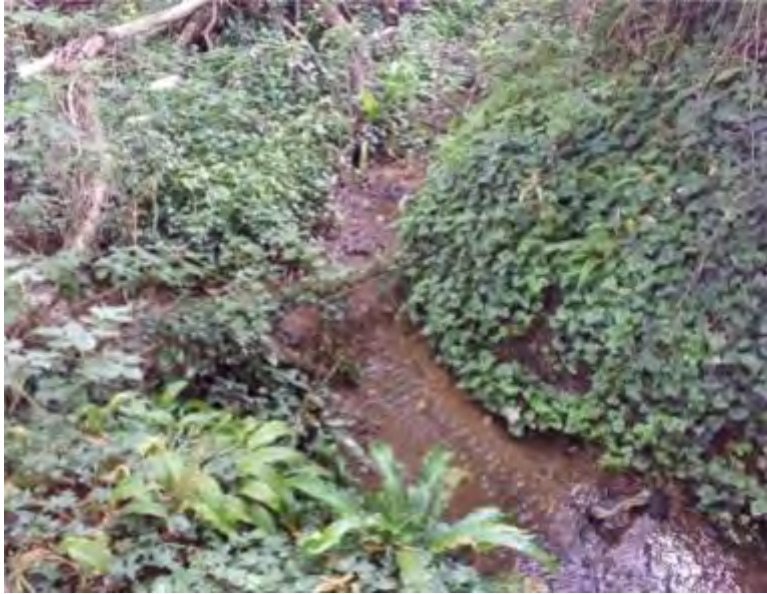
Water course	Date	Scoped out/survey required	Reason	Habitat Description	Photo
24	04/06/19	Surveys required	Sections of suitable habitat present	Shallow, slow moving stream. In the northern section, banks are quite bare with short grass surrounding and high levels of disturbance from horses, dogs and people. In the southern section the water course is wider and deeper (but still >1m) and heavily shaded, surrounded by deciduous woodland. Food availability varies – along most of the watercourse there is limited availability although there are patches in places.

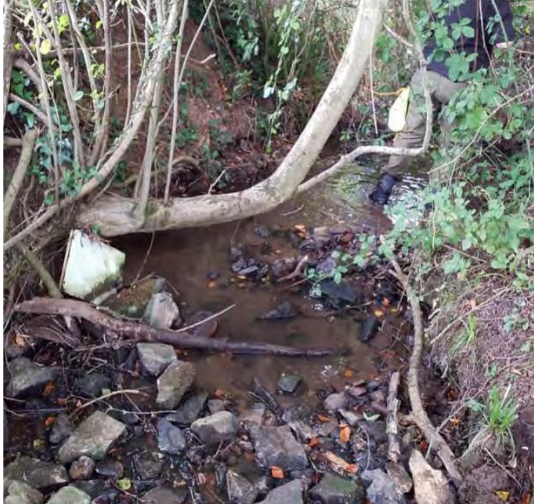
24a	11/09/19	Surveys required	Sections of suitable habitat present	Stoney bottomed watercourse with steep earth banks on one side and shallower banks on the other. Lots of vegetation (mostly bramble) occasionally blocks view along bank. Food sources for water vole are not abundant within the watercourse although they are present in places.

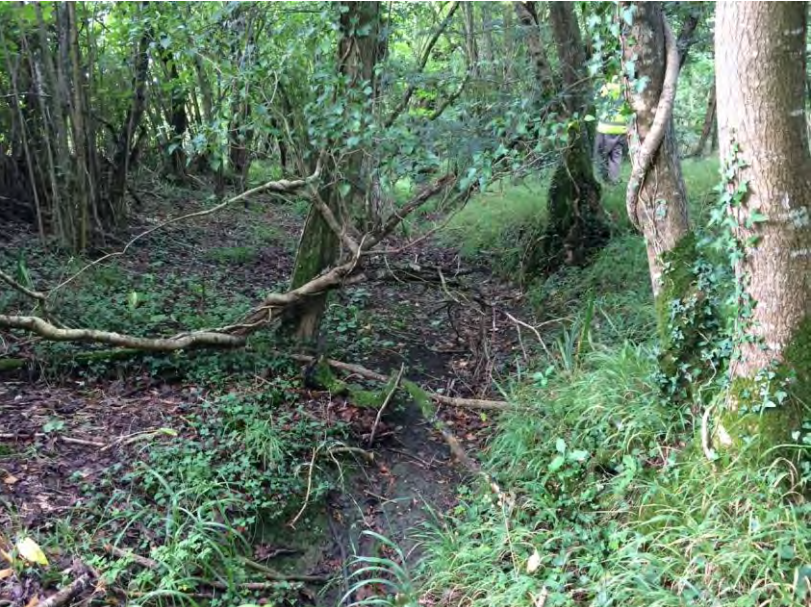
Water course	Date	Scoped out/survey required	Reason	Habitat Description	Photo
31	18/07/17	Scoped out southern section	Dry and overgrown in section or water shallow with banks bare or ivy-covered within woodland.

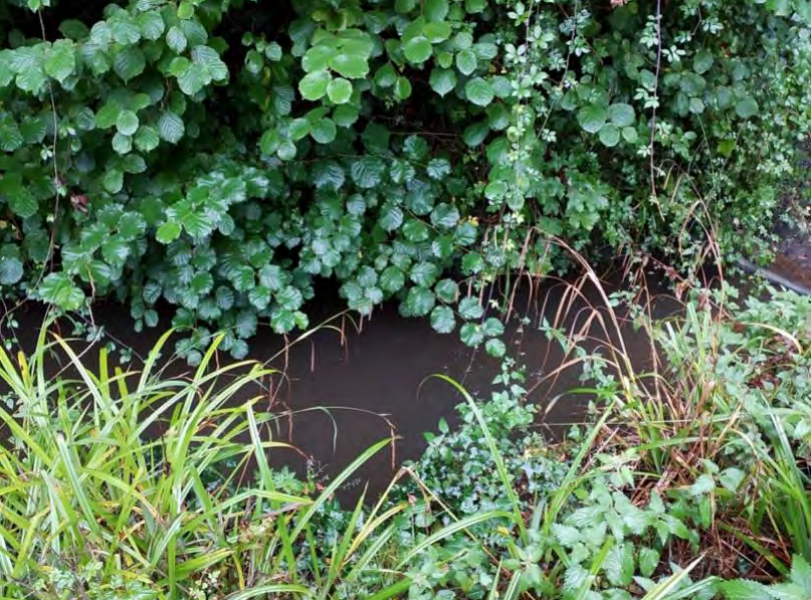
10/09/19	Surveys required	Suboptimal habitat - some areas of suitable habitat and food availability present (although limited)	Ditch with shallow earth banks. Predominantly within woodland with little to no bankside vegetation. Slopes are mossy or bare with ivy covered sections. Adjacent habitat is permanent grassland pasture or arable crop. Little understorey in woodland and bankside vegetation lacked structure. Food source limited – some tall grasses/sedges available.

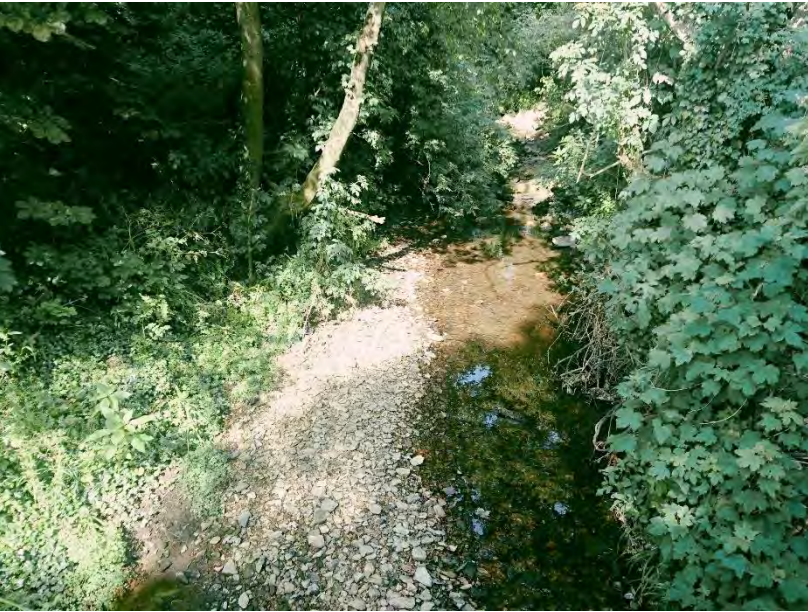
Water course	Date	Scoped out/survey required	Reason	Habitat Description	Photo
34	21/06/17	Surveys required	Suboptimal habitat due to low food availability and lack of connectivity but some suitable areas present	<p>Vertical/undercut bank (natural erosion) with no vegetation cover on one side and pebble/boulder bank dominated by Himalayan balsam, willowherb and nettles on the other. Mosaic of shallow flow over pebbles and deep static pool. Predominantly heavily shaded by bankside trees (hazel, willow, hawthorn), bushes and fallen tree debris. Mosaic of wild garlic, fern sp., ivy, common hogweed and brambles dominate understorey with occasional pendulous sedge, in shaded barer areas.</p> <p>The stream has evidence of hard engineering and baffles. However, natural forming meanders are present away from settlements. There are multiple barriers including roads, concrete bridges and weirs. However, there are pebble beaches, boulders, piles of wood and banks offering plenty of ledges for water voles. The water levels are currently low but the stream rarely dries and the banks are heavily shaded reducing the number of grasses and sedges. There are pools and riffles with pebble beaches, fossils and exposed limestone bedrock within the stream.</p>

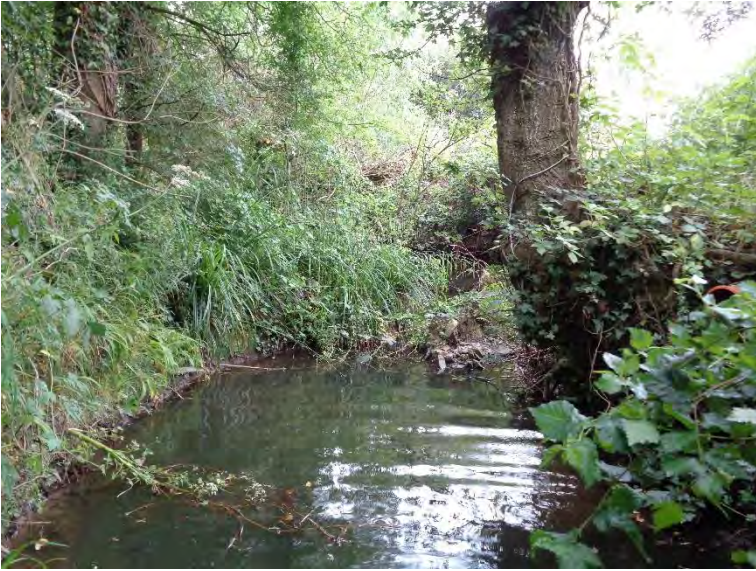
35	22/06/17	Scoped out	Field signs recorded adjacent to a property at the western end of the watercourse (burrow, run, footprints and feeding station), are thought to be rat and not water vole due to isolation of the watercourse and unsuitable habitat along the rest of its length.	Fairly narrow and short wet ditch (<20m wet), small pools of standing water on section closest to the road. The rest of the ditch is shaded and dry. Bankside habitat comprises ivy, brambles, nettles, cow's parsley, field maple, hawthorn, oak, ash, hazel.	
36	23/06/17	Surveys required	Sub-optimal habitat but some suitable areas present	Open and wide (2-5m) channel. Pools of standing water, pebble and silt channel, fallen and overhanging mature trees, several deadwood and flood debris piles along length. Predominantly heavily shaded by bankside trees (90% shading), bushes with sporadic patches of dense bramble and rose scrub. Bramble, pendulous sedge, elder, hazel, willow, hawthorn, blackthorn. Static pools with vertical earth banks in most part.

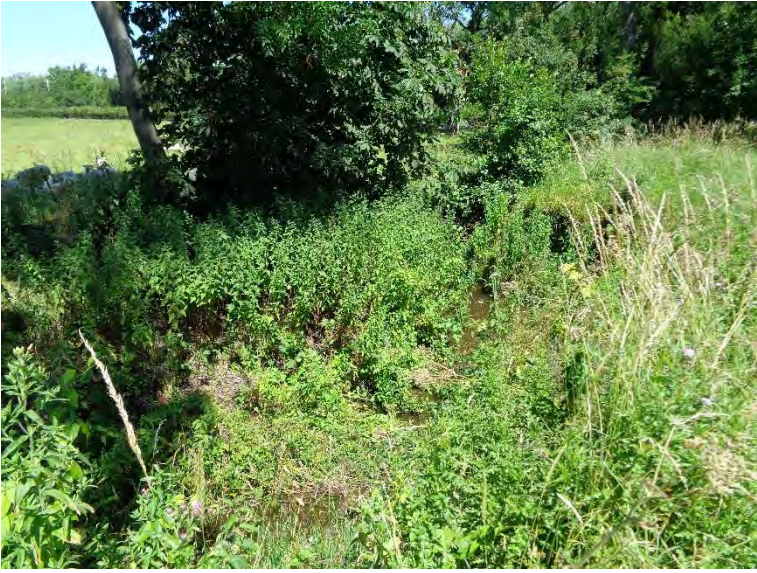
Water course	Date	Scoped out/survey required	Reason	Habitat Description	Photo
			within residential gardens – isolated).		
39	05/07/17	Surveys required	Suitable habitat – herbaceous banks and suitable substrate and bank profile for burrowing	50% shading from woodland (ash, plum, elder, horse chestnut), tall grasses and herbaceous species along banks (including pendulous sedge, willowherb and nettle). Water <0.5m deep, ~2m wide, slow flow. Vertical earth banks, with small areas of bank erosion by sheep in adjacent field.

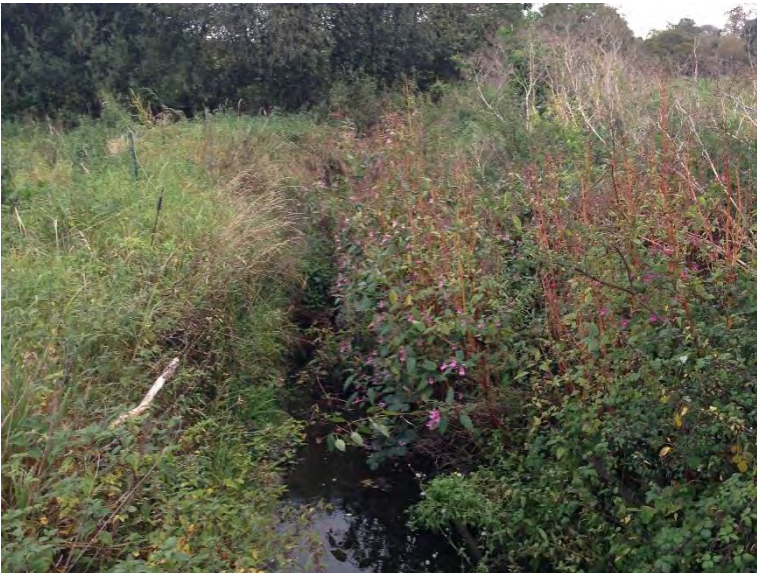
27/09/17	Surveys required	Suitable habitat – herbaceous banks and suitable substrate and bank profile for burrowing	Shaded habitat with woodland (50% shading) some areas of watercourse not shaded comprise a mixture of tall grasses, frequent bankside trees (ash, plum, elder, horse chestnut), bankside herbs and aquatic umbellifers (including fool's water cress, pendulous sedge, Himalayan, fool's water cress within the stream). Vertical earth banks, low flow, 0.5-1m depth and ~2m wide.

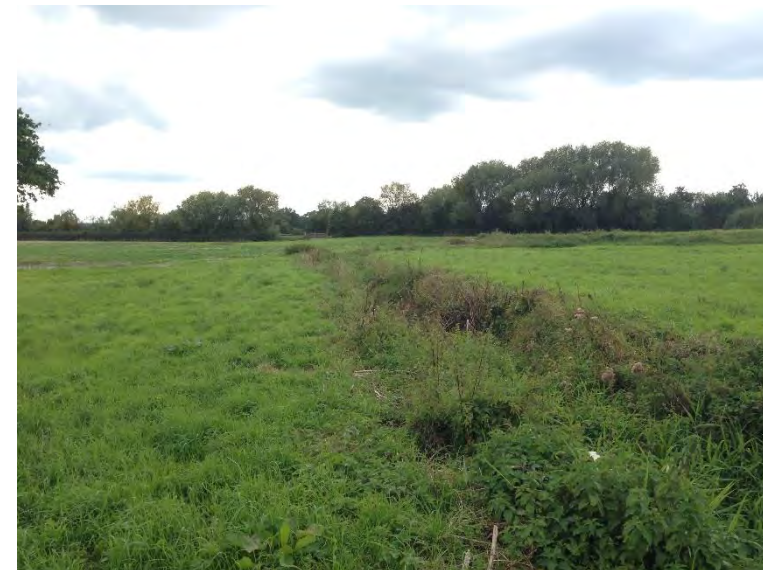
Water course	Date	Scoped out/survey required	Reason	Habitat Description	Photo
46	19.09.2017	Scoped out	Dry		
47	19.09.2017	Scoped out	Dry		
48	29.06.2017	Scoped out	Dry		
49	29.09.2017	Scoped out	Dry or shallow, overgrown		
50	20.07.2017	Scoped out	Dry, overgrown		
51	19.09.2017	Scoped out	Dry or shallow, overgrown		
52	19/09/17	Surveys required	Suitable habitat – herbaceous banks and suitable substrate and bank profile for burrowing	Steep earth banks overgrown in the western section of the stream where it is very shallow, with a slow flow and deep pools. The stream flows faster in the east and the water depth increases to 10cm with beaches and pools. Aquatic and bankside vegetation comprised water hemlock, water mint, bramble, nettle, broadleaved dock and grasses. 70% shading.

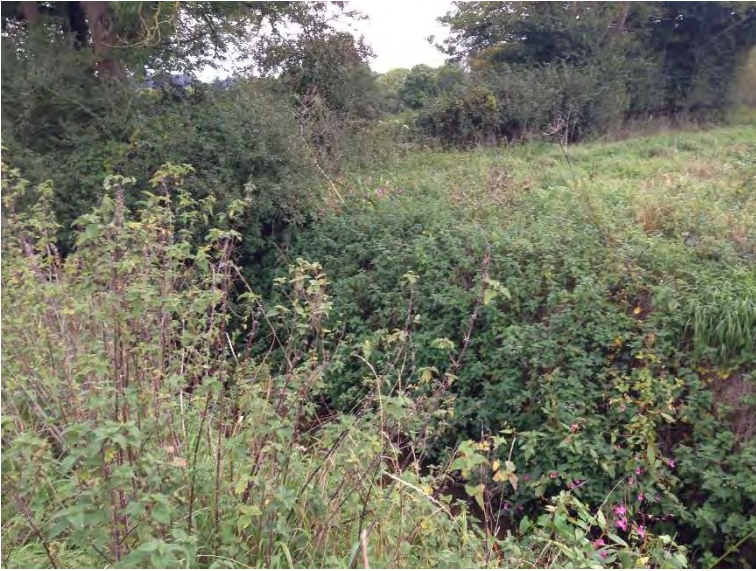
Water course	Date	Scoped out/survey required	Reason	Habitat Description	Photo
55	25/09/17	Surveys required	Suitable habitat – herbaceous banks and suitable substrate and bank profile for burrowing	Variable width (1-2m) and depth (1-2m) in areas with riffles, pools, beaches and waterfalls. Predominantly vertical earth banks with concrete reinforcement near the highways. The channel becomes deeper towards the east. 80% shading. Mosaic of vegetation, comprising bramble, nettle, broadleaved dock, water mint, ash, oak, blackthorn and sedges.

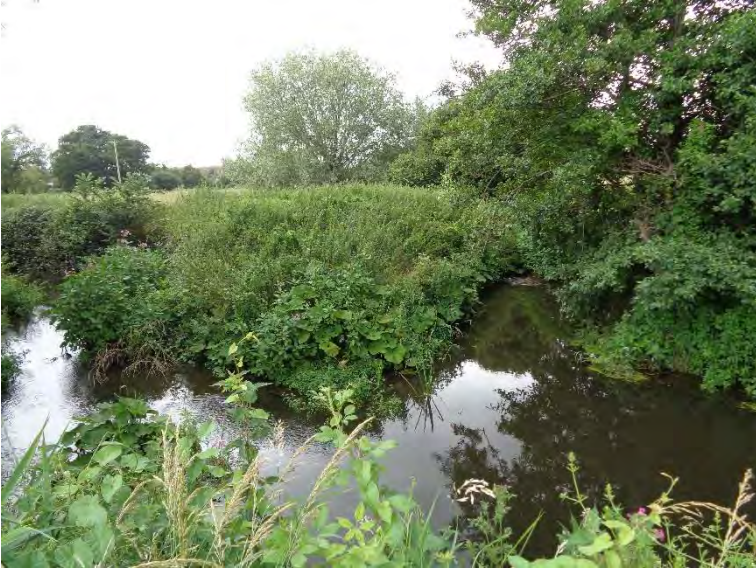
56	20/07/17	Scoped out	Unsuitable habitat, overgrown and dry		
57	29/06/17	Surveys required	Suitable habitat – herbaceous banks and suitable substrate and bank profile for burrowing	Meandering river, water depth over 2m, variable flow (slow to rapid), width (2-15m) and height of vegetated banks. Bankside habitat comprised predominantly of hawthorn, bramble, willow, tall grasses creating in 20% shading along watercourse. Path along some section of watercourse, not heavily used and set back from the water's edge (>3m).

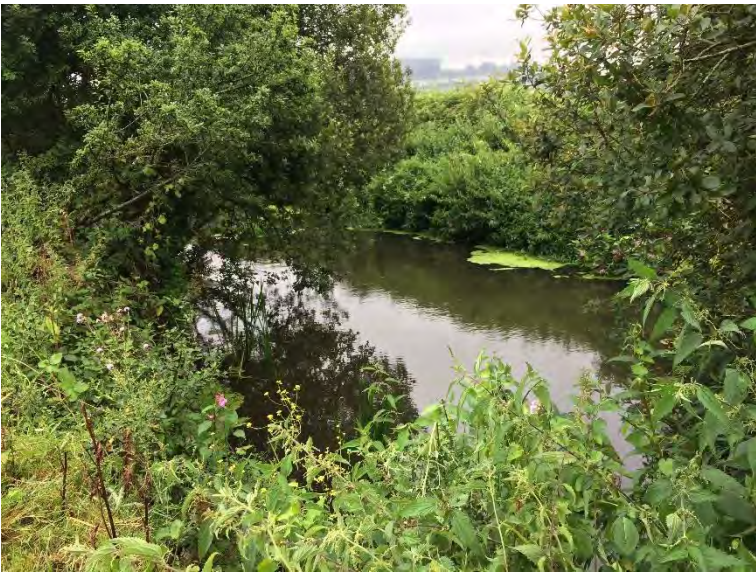
Water course	Date	Scoped out/survey required	Reason	Habitat Description	Photo
	19/07/17	Surveys required	Suitable habitat – herbaceous banks and suitable substrate and bank profile for burrowing	Sections suitable to support water vole comprise bankside dominated by Himalayan balsam, nettles, tall grasses, sporadic patches of bramble and scattered willow tree species (40% shading). These suitable areas comprise steep earth banks, varying in height. On average, water flow is moderate (variable – sluggish to fast), estimated to be 1-2m deep (variable along some lengths of the River Isle) and the watercourse is typically wider than 4m (5-10m).

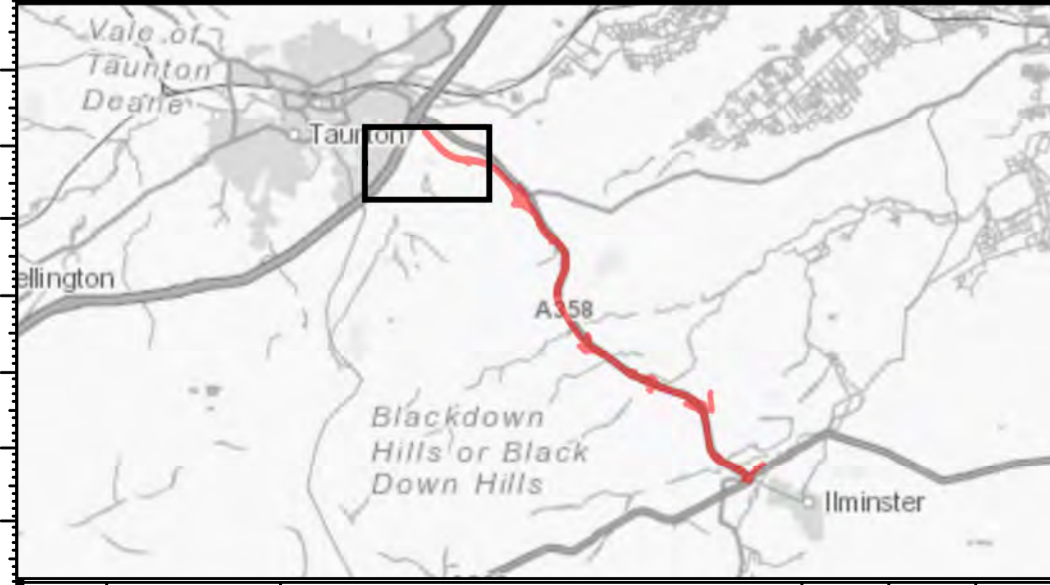
3.4.1. Six latrines observed in June on watercourse 17 are indicative of one female. In addition, a 'plop' sound was heard three times during the same survey suggesting potentially a maximum of three water voles were disturbed, however only latrines can reliably be used to estimate relative population size. A maximum of 19 burrows and two feeding stations were recorded along watercourse 17. These records suggest a low population of water voles are present along watercourse 17.

Notes	Key to symbols	Record	References drawings
Pink Modified Scheme, Mott MacDonald (2018) Watervole field signs, Mott MacDonalds (2017 - 2019) Service Layer Credits: Contains OS data © Crown Copyright and database right 2020	— Pink modified scheme option — Watercourse - - - 250m buffer	● Burrow ● Feeding signs ● Footprint ● Latrine ● Plop sound

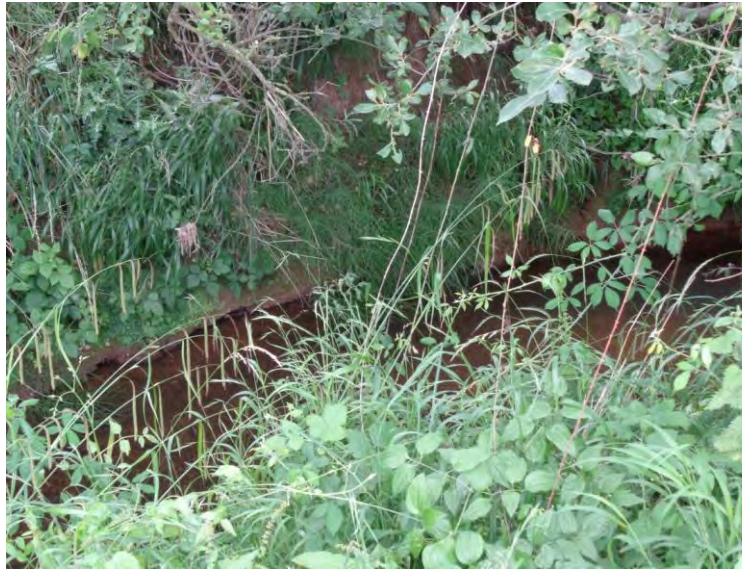
15a	20/05/19	325929	125313	Unknown	Water vole field signs found at ST25929 25313 (outside 250m buffer)	N/A
17	27/06/17	325954	123803	Burrow	Two burrows on west bank

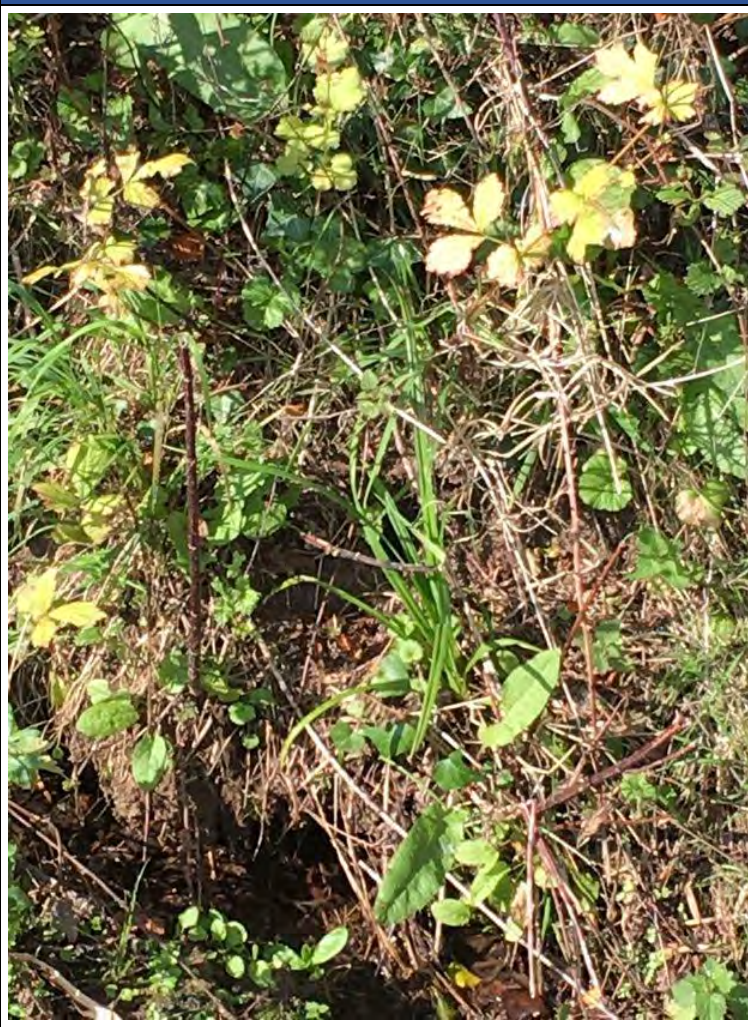
Watercourse	Date	Easting	Northing	Feature	Notes	Photo
17	12/09/17	325830	123435	Burrow	At water level

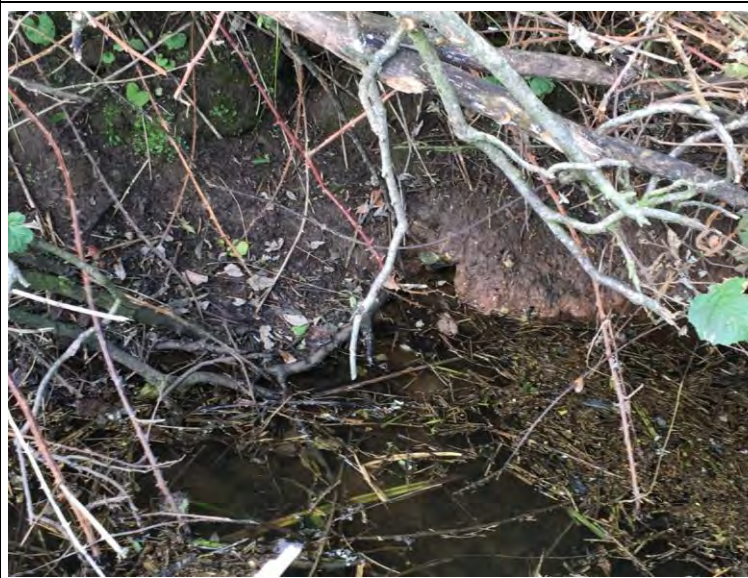
Watercourse	Date	Easting	Northing	Feature	Notes	Photo
17	21/02/20	Burrow	325994	124135	Burrow with mown lawn	 
19	14/09/17	326399	123957	Other	"Plop" sound heard by both surveyors	N/A
19	12/09/19	326210	124140	Burrow	More likely to be rat given lack of other field signs

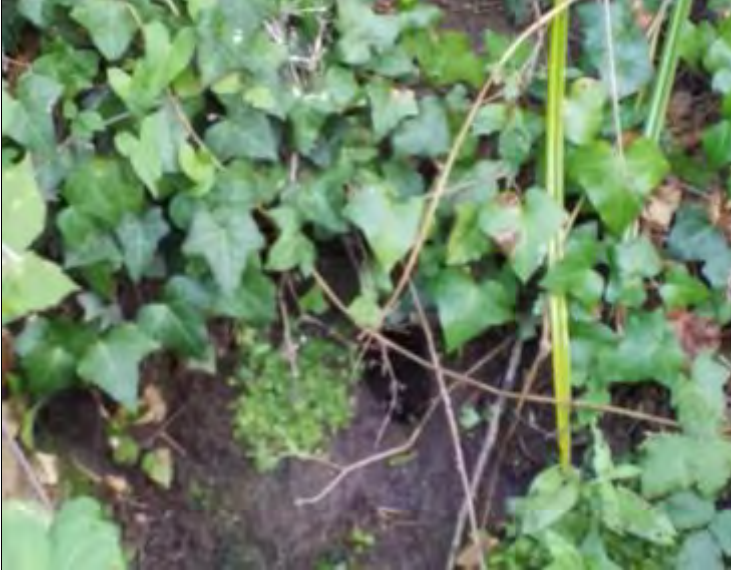
Watercourse	Date	Easting	Northing	Feature	Notes	Photo
19	12/09/19	326516	123838	Burrow

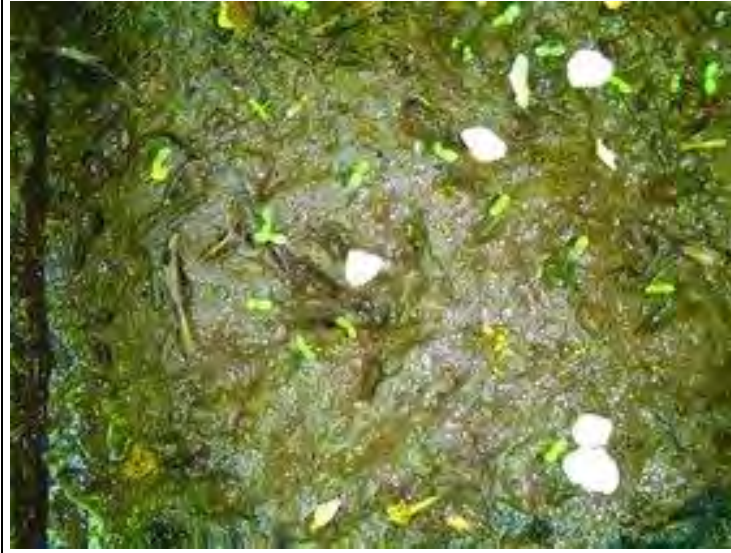
20	12/09/19	326298	123991	Feeding remains	Feeding signs within fool's watercress, likely water vole although too far to confirm fully - near where footprint was identified

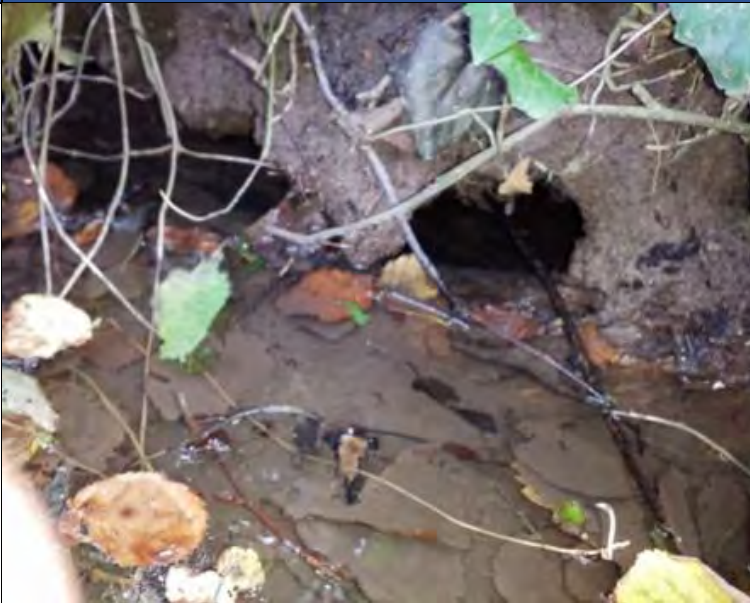
Watercourse	Date	Easting	Northing	Feature	Notes	Photo
24	11/09/19	327555	123661	Burrow	One potential burrow on waterline, west bank

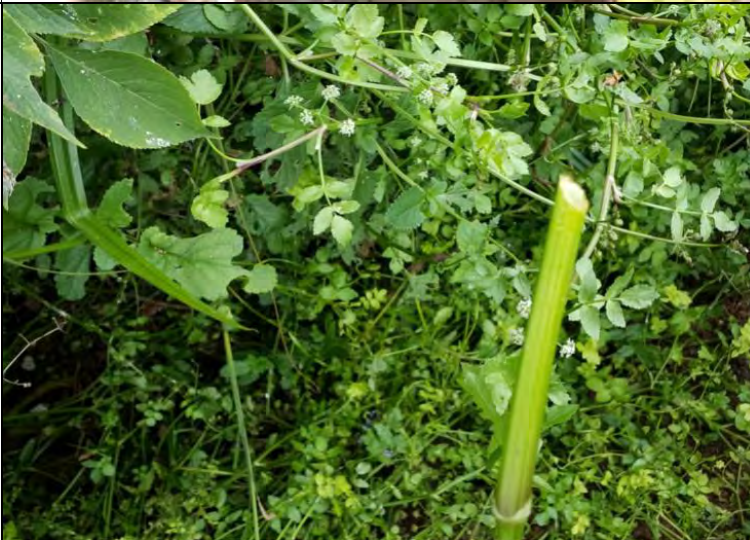
24	11/09/19	327681	124135	Water vole sighting	Water vole seen running from vegetation during survey Feeding station with mown lawn and grass eaten at 45 degree angle Not within 250m buffer

3.3.7. Several feeding stations (vegetation eaten at a 45 degree angle) and active burrows were found on watercourse 24a confirming presence here. Approximately 300m north of the buffer on watercourse 24, a water vole was spotted and feeding remains, burrows and footprints also identified. On the section of watercourse 24 within the buffer, a single potential water vole burrow was identified in August 2020. Although the two watercourses are connected, the evidence on watercourse 24a and the evidence recorded outside the buffer are both over 400m away from the burrow recorded on watercourse 24 and are therefore too far away for presence to be confirmed on this section of watercourse.

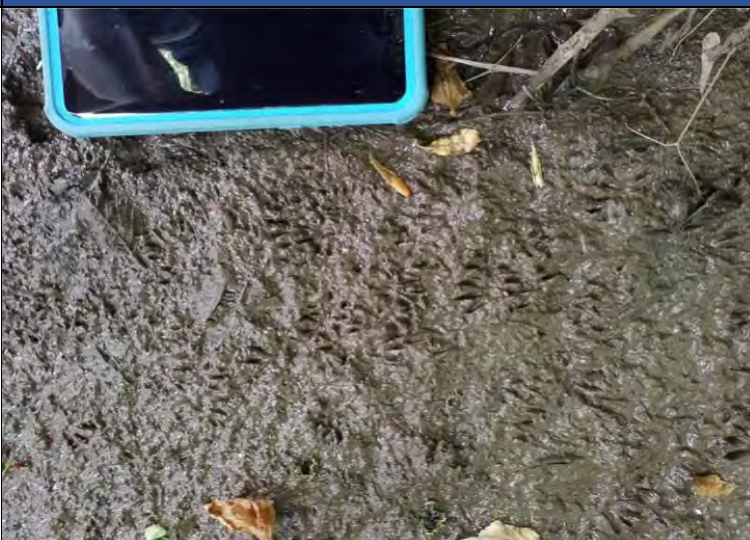
24a	13/09/19	327702	123114	Feeding signs	Vegetation eaten to 45 degree angle

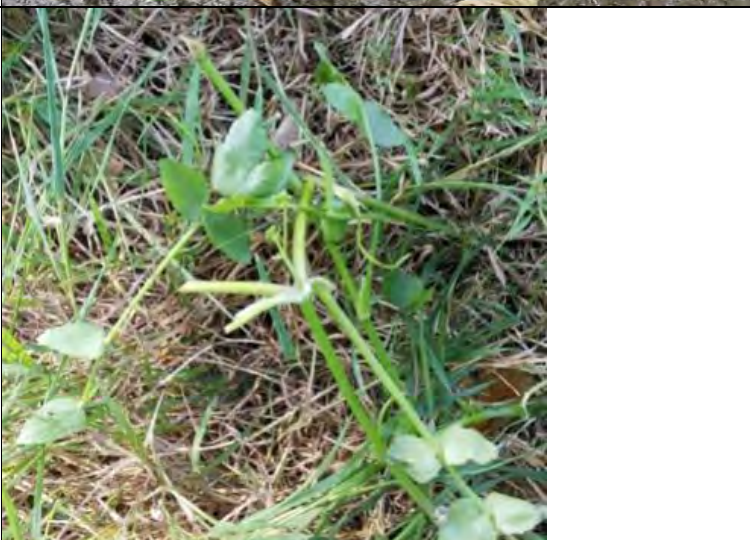
24a	11/09/19	327644	123230	Burrow	Well used, just above waterline

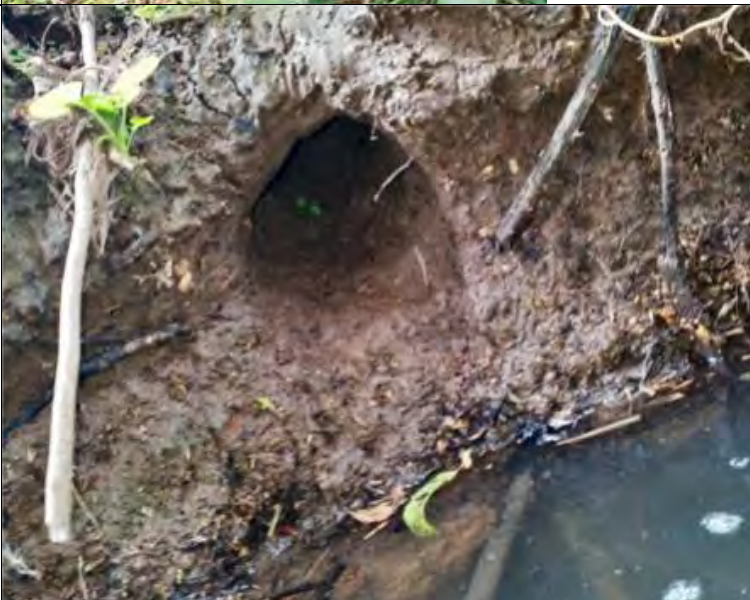
Watercourse	Date	Easting	Northing	Feature	Notes	Photo
24a	10/06/20	327715	123090	Feeding signs	Feeding signs, multiple feeding signs in water, vegetation eaten at 45 degree angle

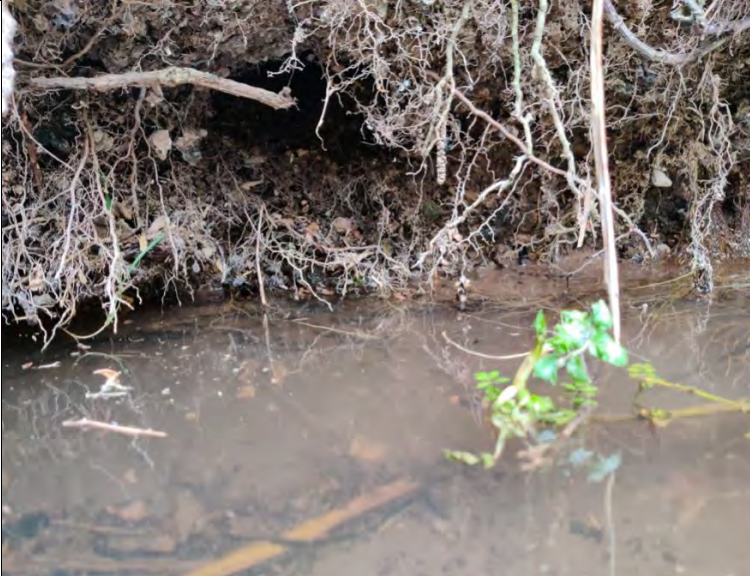
30	11/09/17	328369	120684	Burrow	Outside 250m buffer. Possible water vole burrow x2 (one presumed disused). No other signs.

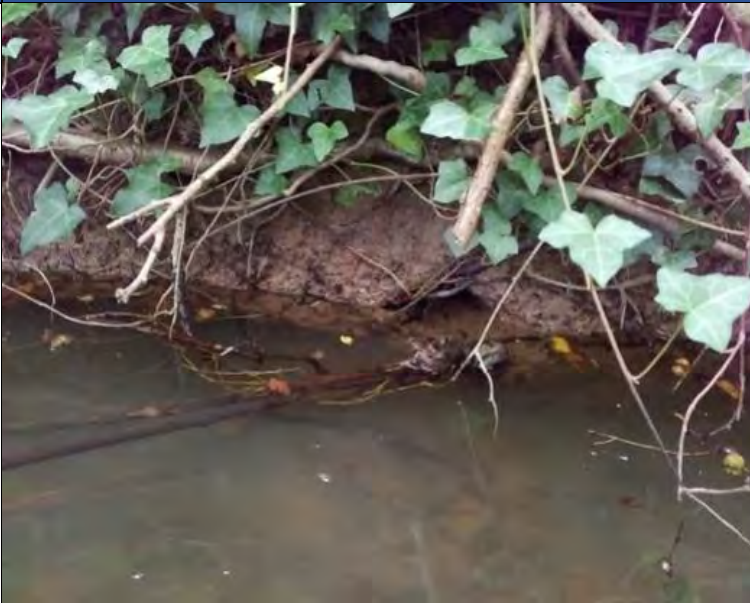
Watercourse	Date	Easting	Northing	Feature	Notes	Photo
30	12/09/19	329246	121457	Burrow	Possible burrow on waterline, no other field signs

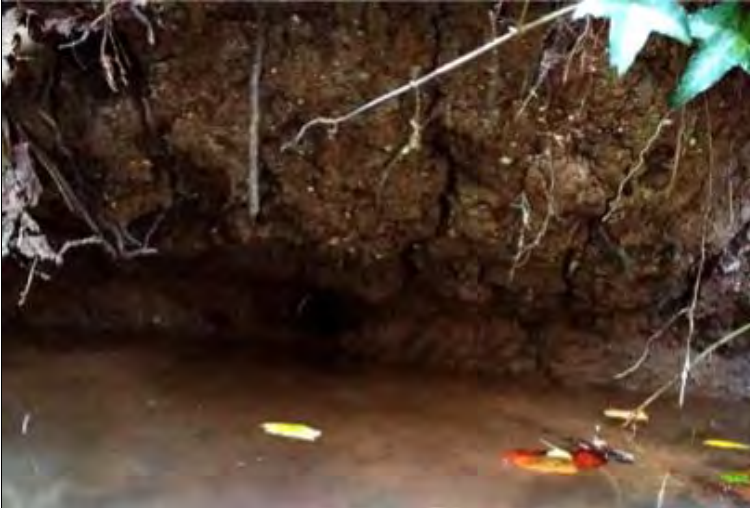
30	12/09/19	329237	121478	Burrow	Possible burrow on waterline

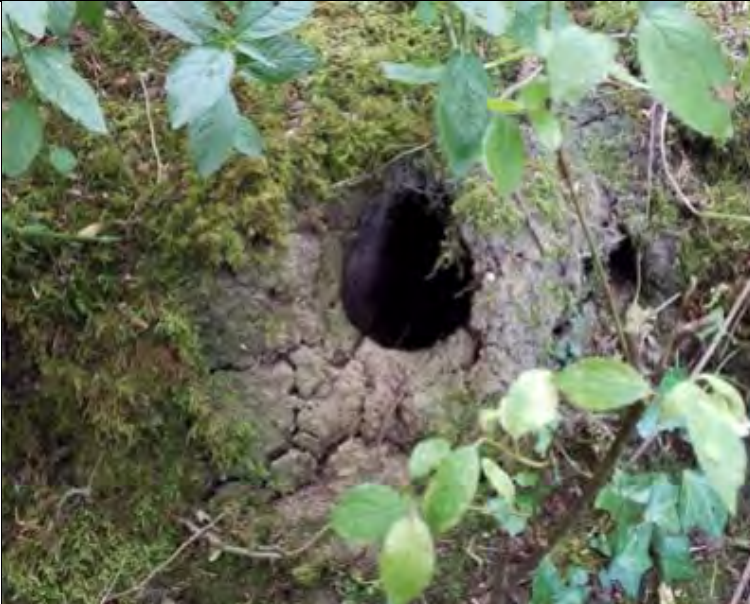
30	09/06/20	328967	121055	Burrow	Possible water vole burrow in bank, approximately 10cm wide

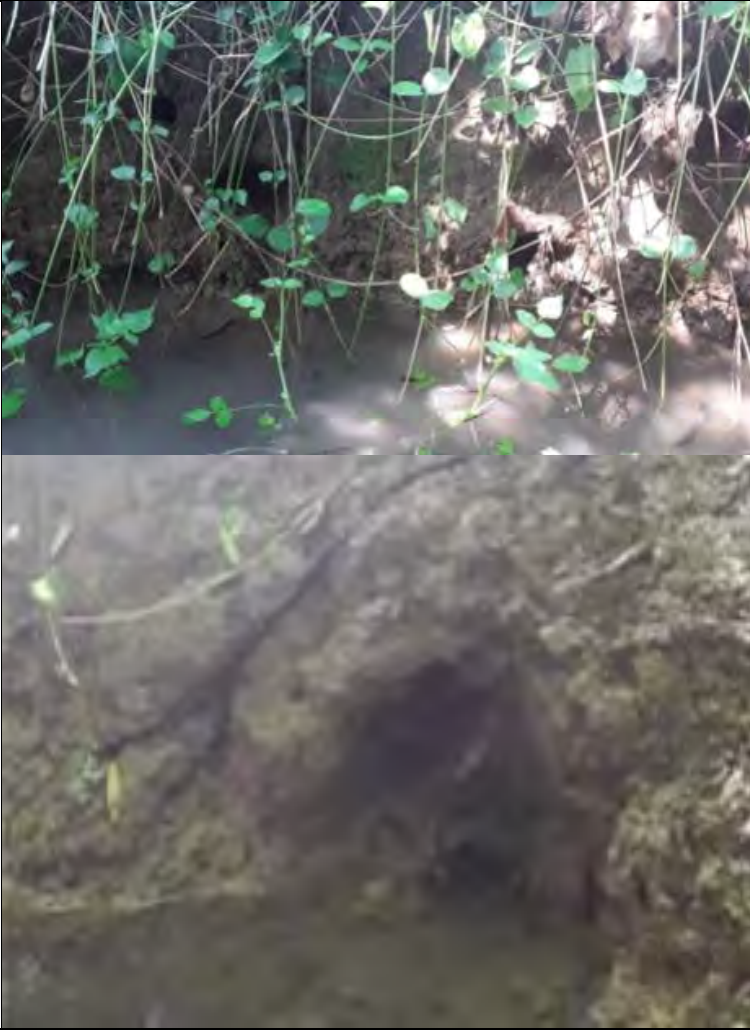
31	21/05/19	329882	121194	Other	Rat droppings and burrows identified

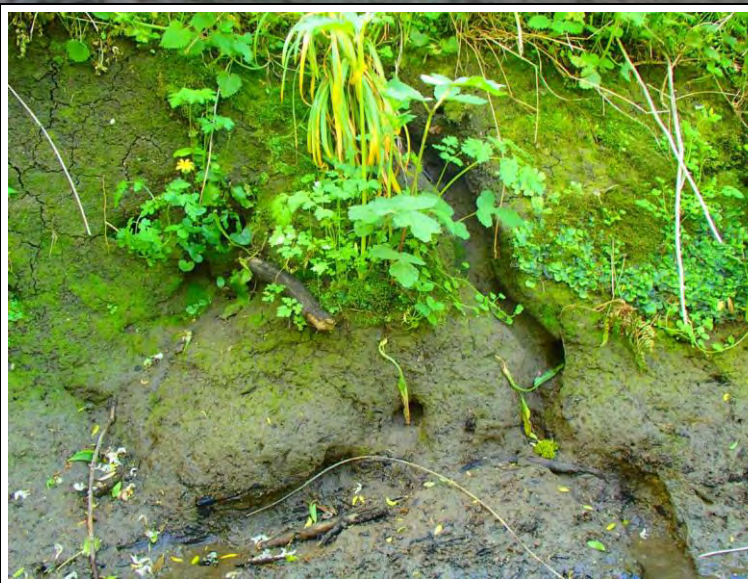
Watercourse	Date	Easting	Northing	Feature	Notes	Photo
39	10/05/18	331545	117848	Burrow	Potential water vole burrow with cut grass above and further tunnel entrance below the water
