A358 Taunton to Southfields Dualling Water vole Technical Report

PCF STAGE 2

HE551508-MMSJV-EBD-000-RP-LB-0046

Date: May 2021

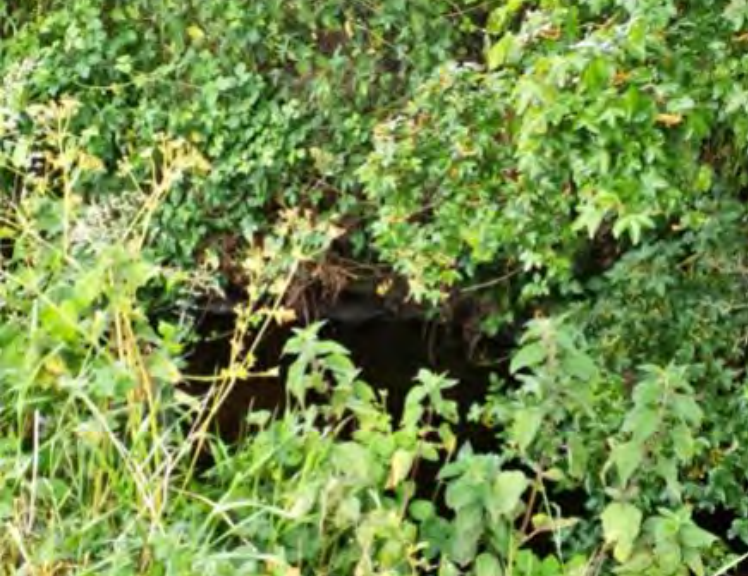
Watercourse	Date	Easting	Northing	Feature	Notes	Photo
39	10/06/20	331662	118085	Burrow	Possible burrow, can't get close enough to investigate

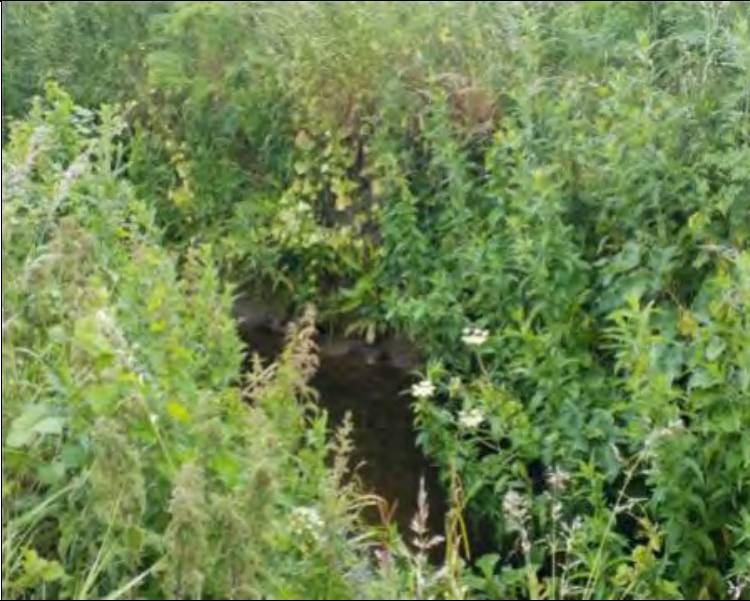
39	10/06/20	331706	118116	Burrow	Small burrow close to water surface - possible water vole
