Preliminary Environmental Information Report

Volume 3: Appendix 17.3

**Detailed Quantitative Risk Assessment
- Human Health**

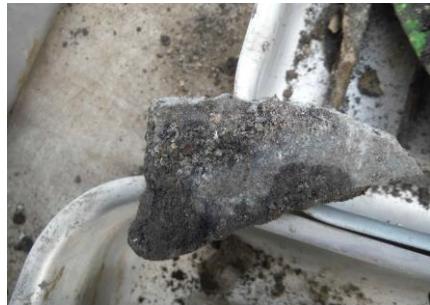
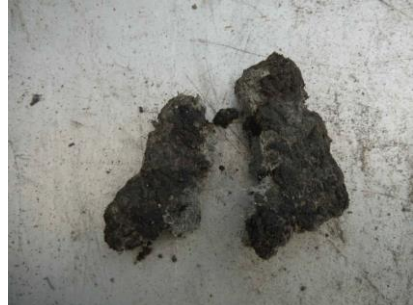
| <p>TP244 – Sheet potentially containing asbestos</p> | <p>TP251 – Sheet potentially containing asbestos</p> |
| <p>TP 268A - Cement possibly containing asbestos.</p> | <p>TP 275 – Tile possibly containing asbestos</p> |

3.4.7 ACMs were visually identified in 36 of the 185 exploratory locations (19%). The visual observations suggest that the ACMs were observed in most waste types. No visual observations of ACMs were noted within the cover material (both chalky and non-chalky). The number of observations of ACMs in different waste types is shown in **Table 3.4**. Visually observed ACMs were commonly encountered in old domestic and commercial types, 26% and 64% respectively.

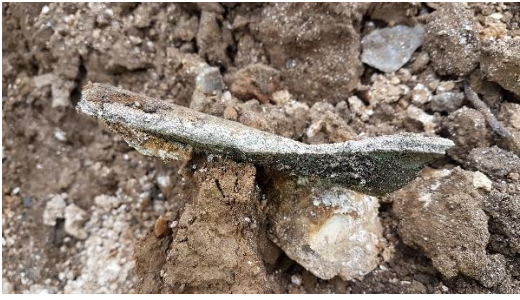
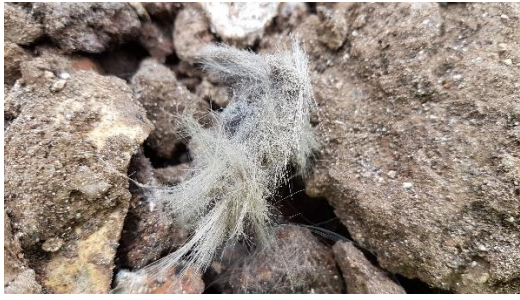
Image 3-2: Selected photographs of potential ACMs within the former scrapyard

| <p>TP104- Cement board possibly containing asbestos</p> | <p>TP104- Bundles of loose fibres found at base of trial pit</p> |

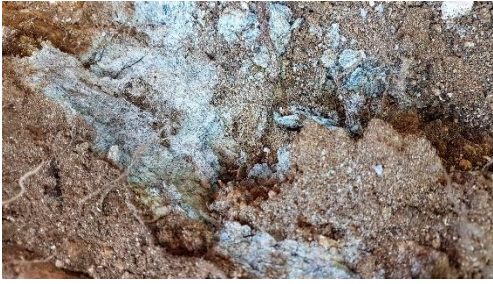
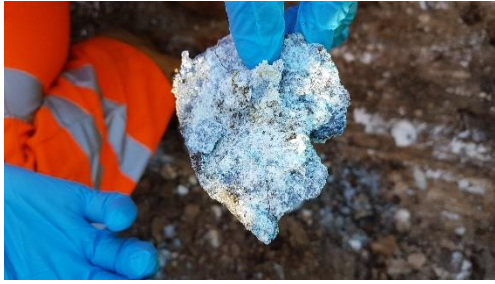
| <p>TP105- Fragments of possible asbestos material</p> | <p>TP105- Fragments of possible asbestos material</p> |

3.4.12 Out of the 17 exploratory locations undertaken visual observations of ACMs were made in six of the locations (35%). The visual observations of asbestos were all located within the bund material surrounding the area of the current Tidy Tip (**see Image 3-2**). This bund material comprised of reworked natural soils, demolition rubble, glass, metal, plastic and other waste. Historical maps and other records suggest the bunds were formed when the scrapyard was cleared and levelled to form the Tidy Tip site (Ref. 10)

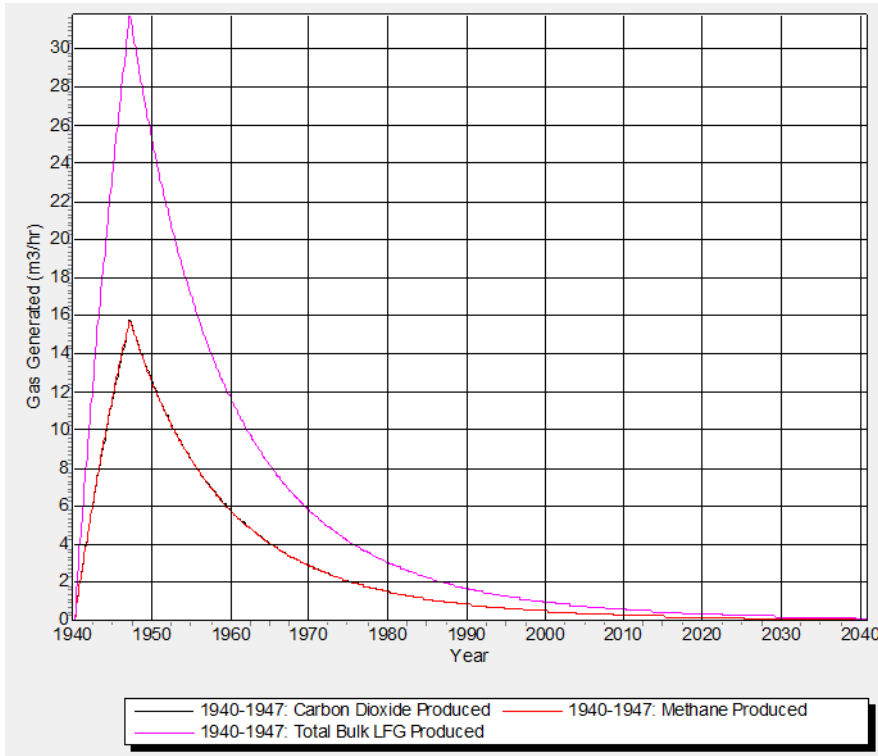
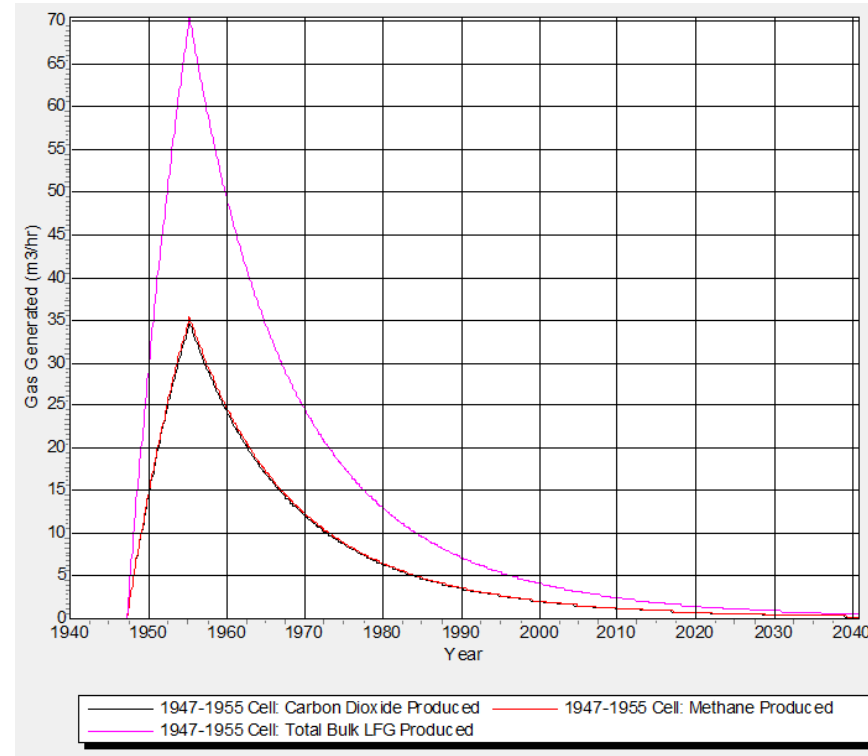
- 4.4.14 The output selected is the total gas generated as the former landfill does not have a gas collection system.
- 4.4.15 Gas production for all eras rises sharply after the first year of filling and is indicated to peak approximately 10 years after first placement of the waste with a sharp decrease in production over the following twenty years with production of gas falling at a slower rate for subsequent 30 years.

- 4.4.16 The results indicate the source term for the waste placed in the eras 1940 to 1970 is essentially depleted with current gas generation estimates for CO₂ and CH₄ between 0.2 to 1.7 m³/hr. In contrast the 1970 to 1980 cell which contains approximately 50% of the landfill mass is also producing approximately 80% of the landfill gases, producing landfill gas at a maximum rate for total gas of 22.5 m³/h.

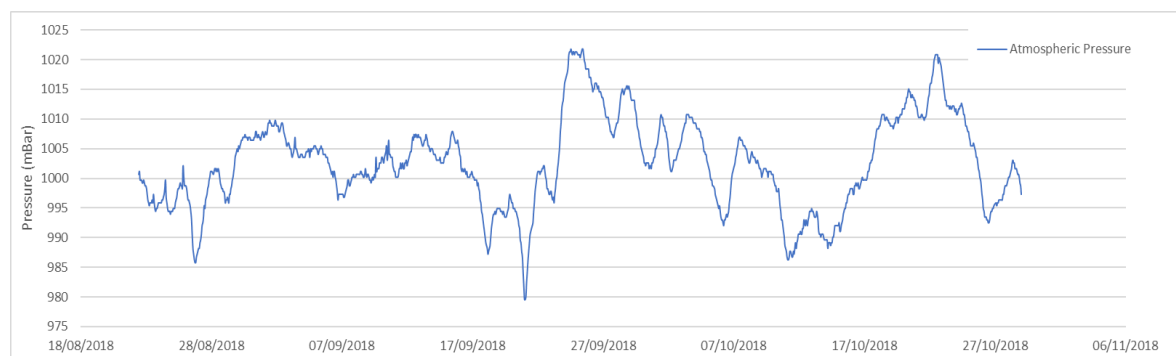
Figure B1 Atmospheric pressure recorded during high-frequency monitoring period

B1.2.2 The atmospheric pressure data has been reviewed to assess if the data has been collected over a sufficient number of relevant pressure variations to allow the prediction of “worst-case” atmospheric pressure conditions¹. A fall in atmospheric pressure is an important ground-gas driver on many sites and in particular the rate and duration of the fall are considered to be the key factors².
